# Manhole Inspection Summary

## Manhole # S15MM\_012MH

Insp Date: **9/10/07 4:17 PM**

**Location** Address: **2613 WINDSOR AVE**

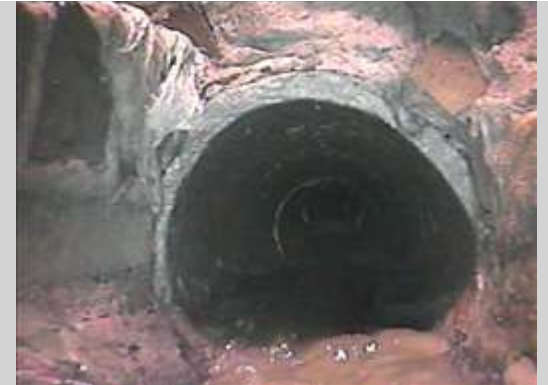
12 O'Clock Outflow

8 in. Circular Gravity Sewer  
Pipe Out @ 12 O'Clock

Pipe Material: **Clay** ☐ Pipe Lined

Invert Depth: **10.39** (ft.) Flow Characteristics: **Slow**

Deposits: ☒ None ☐ Mud ☐ Sludge ☐ Debris ☐ Grease

Infiltration: **None** Pipe Seal Cond: **Sound**

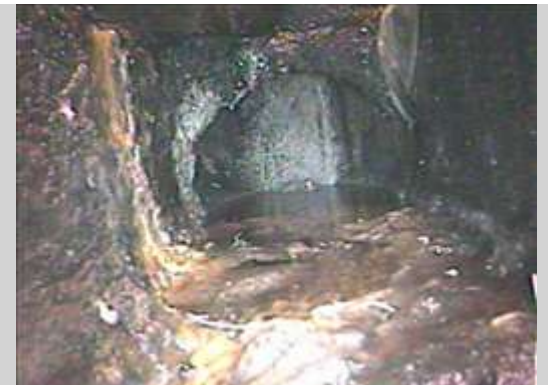
6 O'Clock Inflow

8 in. Circular Gravity Sewer  
Pipe In @ 6 O'Clock

Pipe Material: **Clay** ☐ Pipe Lined

Invert Depth: **10.32** (ft.) Flow Characteristics: **Slow**

Deposits: ☐ None ☐ Mud ☐ Sludge ☒ **Debris** ☐ Grease

Silt Depth: **3** (in.) Deposits Extent: **Medium**

Infiltration: **None** Pipe Seal Cond: **Unknown**

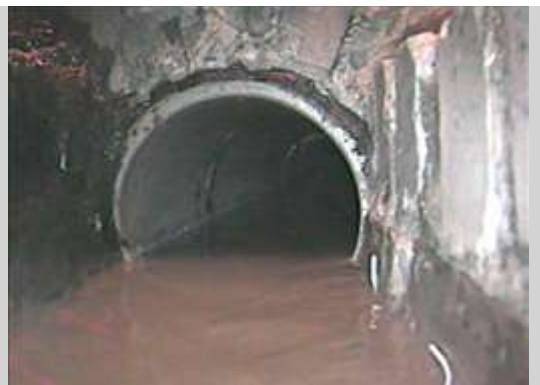
9 O'Clock Inflow

8 in. Circular Gravity Sewer

Pipe In @ 9 O'Clock

Pipe Material: **Clay** ☐ Pipe Lined

Invert Depth: **10.26** (ft.) Flow Characteristics: **Slow**

Deposits: ☒ None ☐ Mud ☐ Sludge ☐ Debris ☐ Grease

Infiltration: **None** Pipe Seal Cond: **Sound**
